SITE OBSERVATION & REPORTING

CONSTRUCTION SAFETY & SITE  
PREPARATION

221-281-VA SECTION 003

VANIER COLLEGE

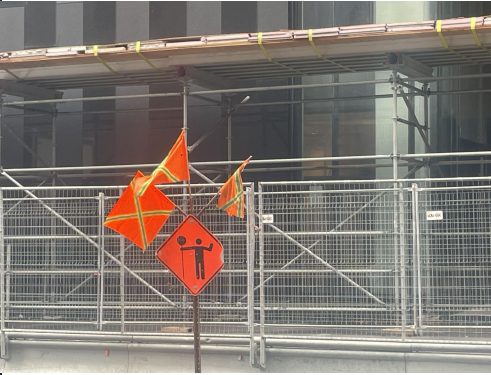
THIS IMAGE SHOWS A TRAFFIC SIGN INDICATING THAT THERE IS A SIGNAL TRAFFIC PERSON AND TRAFFIC FLAGS. THE ARTICLE 10.3.1. STATES THAT THE PRINCIPAL CONTRACTOR MUST ENSURE THAT ANY CONSTRUCTION SITE SITUATED ON A PRIVATE ROAD OPEN TO THE PUBLIC VEHICULAR TRAFFIC HAS TRAFFIC SIGNS THAT COMPLY WITH THE STANDARDS OF THE "TRAFFIC CONTROL DEVICES" MANUAL. THERE IS ALSO A METAL FENCE WHICH ISOLATES THE GENERAL PUBLIC FROM THE CONSTRUCTION SITE.

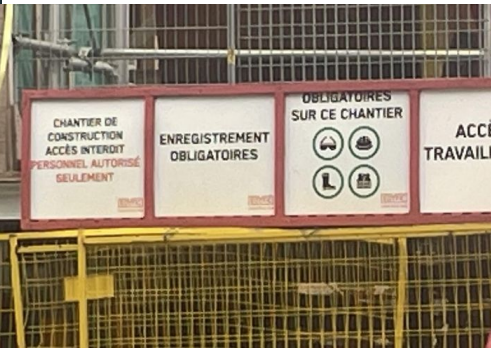
IN THIS PICTURE THERE IS A SIGN INDICATING THAT: UNAUTHORIZED PERSONNEL ARE NOT ALLOWED ON THE SITE, THERE ARE RECORDING CAMERAS, AND THAT PROTECTIVE GLASSES, A HARD HAT, PROTECTIVE BOOTS AND A REFLECTIVE VEST ARE MANDATORY ON THE CONSTRUCTION SITE, AT THE WORKER'S ENTRANCE. THE ARTICLE 3.1.1. OF THE CONSTRUCTION SAFETY CODE STATES THAT ACCESS TO THE CONSTRUCTION SITE SHALL BE AT ALL TIMES LIMITED TO PERSONNEL AUTHORIZED BY THE SITE HEAD.

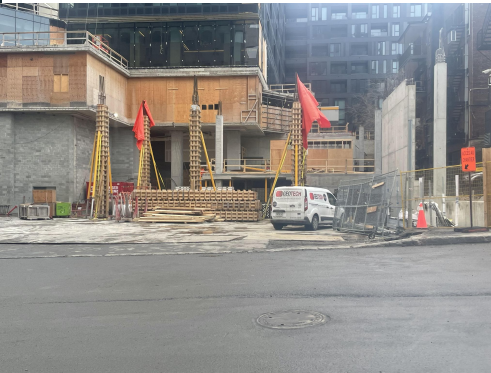
IN THIS PICTURE WE SEE CONCRETE COLUMN FORMS AND A VEHICLE FROM THE GROUPE GEOTECH WHICH IS A COMPANY THAT SPECIALIZES IN CONCRETE SAWING AND CONCRETE SCARIFICATION. IN ARTICLES 6.8..1 AND 6.9.1. (a) OF THE CONSTRUCTION SAFETY CODE, CONCRETE SLABS RESTING ON THE GROUND OR ON FOUNDATION PILES MUST BE DESIGNED TO SUPPORT THE LOADS DUE TO THE SHORING OF THE UPPER FLOORS, AND THEY MUST STAY IN PLACE FOR 21 DAYS UNLESS AN ENGINEER ATTESTS THAT THE CEMENT CAN SUPPORT THE LOADS IT MAY HAVE TO SUPPORT. THERE ARE ALSO WOODEN GUARDRAILS ON THE FLOORS ABOVE, WHICH ARE MANDATORY ON OPEN SIDES OF A FLOOR FROM WHICH WORKERS CAN FALL FROM A HEIGHT GREATER THAN 3M, ACCORDING TO ARTICLE 2.9.2. OF THE CONSTRUCTION SAFETY CODE.

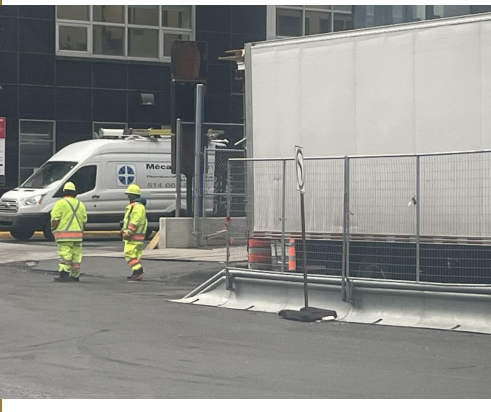
THERE ARE ROADWAY SIGNAL PERSONS WEARING HIGH VISIBILITY SAFETY APPAREL WITH A FLUORESCENT GREEN HAT. WE ALSO OBSERVE THE BACK OF A TRUCK IN ITS BACK UP SPACE ENCLOSED BY A METAL FENCE AND ORANGE TRAFFIC CONES. THE ARTICLE 2.8.2. INDICATES THAT A FLAG PERSON FOR ROAD USERS AND THE LOCATION OF A BACK UP AREA MUST BE PART OF THE TRAFFIC PLAN DESIGNED BY THE PRINCIPAL CONTRACTOR WHO HAS THE OBLIGATION TO PROTECT THE GENERAL PUBLIC AROUND THE JOB SITE AND THE WORKERS.

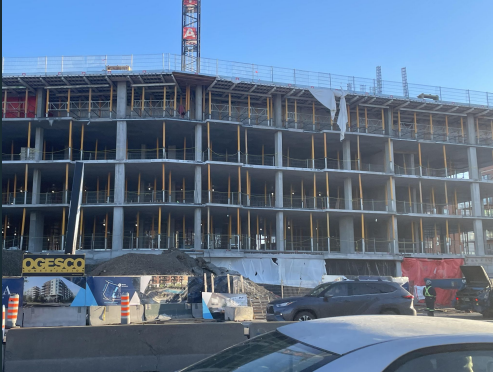
IN THIS PICTURE THERE ARE LIGHTS ON EACH COMPLETED FLOOR WHICH MUST BE TURNED ON AT ALL TIMES. (s. 3.2.4.(f)) SINCE THIS IS A CONCRETE CONSTRUCTION IT IS NOTICEABLE THAT THE SLABS ARE SUPPORTED BY YELLOW TEMPORARY FORMWORK SUPPORT, THEY HAVE TO SUPPORT THE LOADS OF THE UPPER FLOORS UNTIL THE CONCRETE IS FULLY CURED. THE FORMWORK SUPPORTS ARE DESIGNED BY AN ENGINEER AND THEY ARE MEANT TO SUPPORT THE DEAD LOAD OF THE CONCRETE AS WELL AS THEIR OWN. (s. 6.4.1.(a-b))

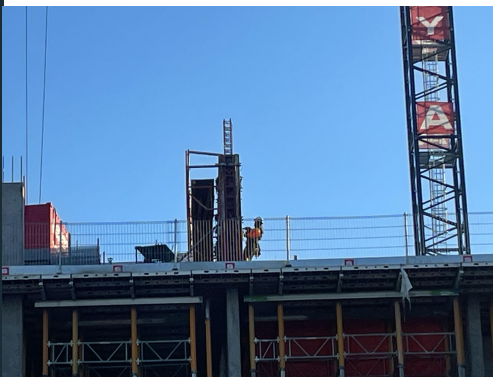
THERE IS A WORKER ON THE LAST FLOOR THEY ARE WEARING A HARNESS WHICH IS ATTACHED TO AN ANCHOR POINT. THEY ARE ALSO WEARING THEIR PPE: A HARD HAT A CSA APPROVED CONSTRUCTION BOOTS. THEIR CLOTHES ENTIRELY COVER THEIR BODY. (s. 2.10.1.) THE FALL ARREST SYSTEM WHICH CONSISTS OF AN ANCHORAGE SYSTEM AND GUARDRAILS MUST BE BUILT IN ACCORDANCE TO THE CSA STANDARDS AND DESIGNED BY AN ENGINEER SINCE IT IS A TEMPORARY STRUCTURE. THE CONFORMITY CERTIFICATE MUST BE KEPT ON SITE AT ALL TIMES. (s. 2.10.15.)

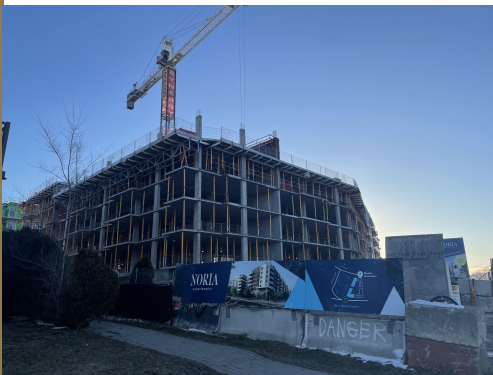
A TOWER CRANE IS IN OPERATION ON THIS CONSTRUCTION SITE. A TOWER CRANE MUST CONFORM TO THE CSA STANDARDS FOR TOWER CRANES. THE OPERATOR MUST UPDATE ITS LOG BOOK IN ACCORDANCE TO THE STANDARDS. (s. 2.15.7.4.) BEFORE ASSEMBLING THE CRANE, THE PLANS MUST BE SIGNED AND SEALED BY AN ENGINEER AND SENT TO THE CNESST. THEN, THE COMPLIANCE CERTIFICATE PROVIDED BY THE ENGINEER SHOULD BE KEPT ON SITE AT ALL TIMES. (s. 2.4.1.(3)) SINCE THE USE OF A CRANE IS A PLANNED PROCEDURE DETERMINED BY THE GENERAL CONTRACTOR IN THE CIRCULATION PLAN, THERE MUST BE AN ON SITE SIGNAL PERSON ASSISTING THE CRANE OPERATOR WHILE CARRYING LOADS OR EQUIPMENT. (s. 3.10.5.)

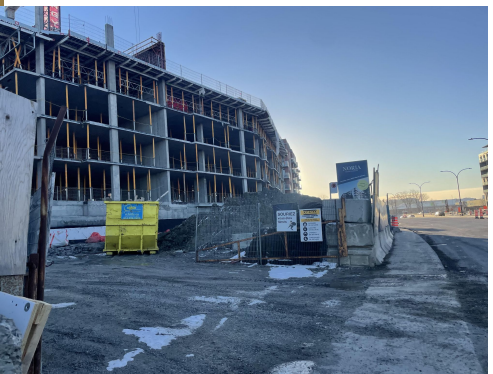
THIS IS THE ROAD ENTRANCE OF THE CONSTRUCTION SITE. THERE IS A PUBLIC NOTICE POSTER INDICATING THAT THERE IS CAMERA SURVEILLANCE. THERE IS ALSO A POSTER THAT SHOWS THE MANDATORY PERSONAL PROTECTIVE EQUIPMENT EVERYONE ON THE SITE SHOULD HAVE ON THEM WHICH CONSISTS OF: A HARD HAT, CSA APPROVED SAFETY BOOTS, A REFLECTIVE VEST AND SAFETY GLASSES. THERE IS ALSO A YELLOW WASTE BIN WHICH IS AN APPROPRIATE CONTAINER FOR WASTE COLLECTION ON A CONSTRUCTION SITE. (s. 3.2.2.(2))

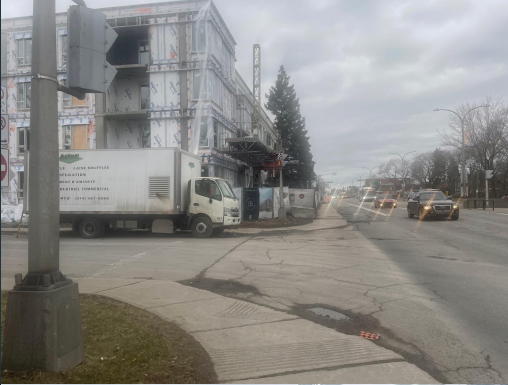
THERE IS A TRUCK THAT BELONGS TO AN INSULATION ALGON 2000, A INSULATION CONTRACTOR COMPANY PARKED NEXT TO THE CONSTRUCTION SITE. THEY SPECIALIZE IN INSTALLING THERMAL, MECHANICAL OR ACOUSTIC INSULATION AND THEY ALSO PROVIDE ASBESTOS ABATEMENT SERVICES. ASBESTOS IS A CONTAMINANT THAT WAS USED TO INSULATE BUILDINGS, IT WAS BANNED IN THE 1980S IN CANADA DUE TO ITS DANGEROUS PROPERTIES THAT CAUSE ASBESTOSIS WHICH CAN TAKE 10 YEARS TO SHOW SYMPTOMS.

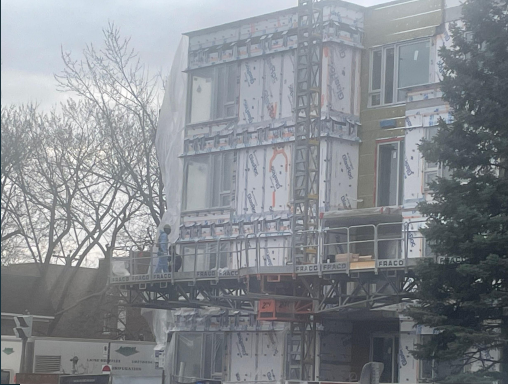
THERE IS A WORKER ON THE MAST-CLIMBING WORK PLATFORM. THE SAFETY CODE REQUIRES THAT A MAST-CLIMBING WORK PLATFORM MUST BE DESIGNED BY AN ENGINEER AND HAVE A VALID CERTIFICATE OF CONFORMITY PROVIDED BY THE ENGINEER. A COPY OF THOSE DOCUMENTS MUST BE ON SITE. THE SAFETY CODE ALSO MENTIONS THAT ANY WORKER ON A MAST-CLIMBING WORK PLATFORM MUST HAVE RECEIVED TRAINING THAT TEACHES THEM TO IDENTIFY AND PREVENT HAZARDS LINKED TO THE MAST-CLIMBING WORK PLATFORM. (s. 3.9.22(1))

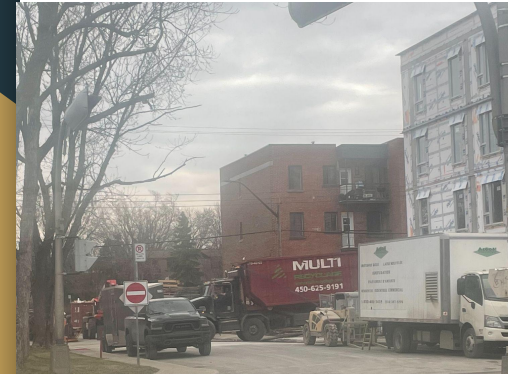
A DUMP TRUCK IS BACKING UP INTO THE CONSTRUCTION SITE. SINCE TRUCKS HAVE A BLIND SPOT ON THE BACK, THE TRUCK MUST BE EQUIPPED WITH A BACK UP ALARM AND MIRRORS, THERE MUST ALSO BE A ON SITE SIGNAL PERSON MONITORING THE MANOEUVER. (s. 3.10.5 (2)) TO HAVE A SAFE AND FLUID CIRCULATION, THE GENERAL CONTRACTOR MUST HIRE AN ON SITE SIGNAL PERSON WHO WEARS AN ORANGE HARD HAT AND ALSO A ROADWAY SIGNAL PERSON WHO WEARS AN ENTIRE FLUORESCENT OUTFIT.(s. 2.8.4.(1)) THIS IS PART OF THE CIRCULATION PLAN DESIGNED BY THE GENERAL CONTRACTOR.

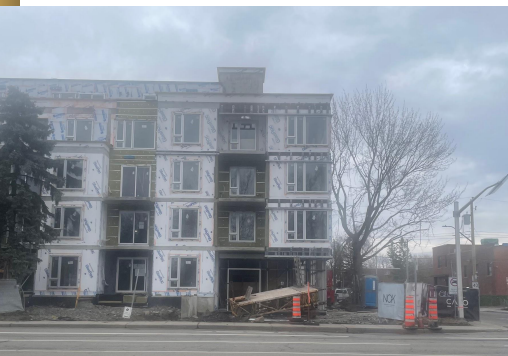
THE ENTIRE WALL SURFACE IS COVERED WITH GLASSROC SHEATING TO PROTECT THE STRUCTURAL STEEL FRAME FROM THE WEATHER. THERE IS ALSO A PORTABLE TOILET ON THE SITE. A TOILET MUST BE INSTALLED ON THE FIRST DAY OF CONSTRUCTION WHEN THE FIRST PERSON ARRIVES. THIS TOILET IS PORTABLE AND NOT FLUSHABLE BECAUSE A FLUSHABLE TOILET IS ONLY NECESSARY FOR A CONSTRUCTION SITE THAT HAS MORE THAN 24 WORKERS. (s. 3.2.7)

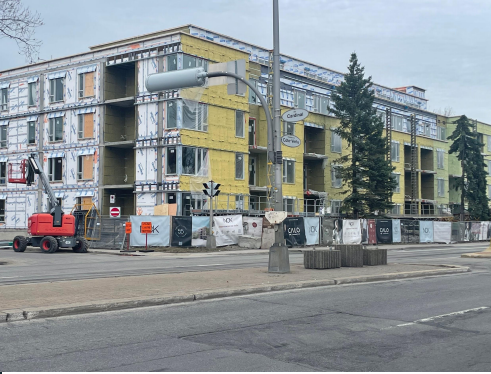
THERE IS YELLOW INSULATING FOAM ON THE FRONT FACE OF THE BUILDING, COVERING THE GLASSROC SHEATHING. THERE IS ALSO A SMALL BOOM TRUCK WITH A BUCKET THAT COULD LIFT ONE PERSON. THERE IS ALSO A FENCE SEPARATING THE SIDEWALK FROM THE CONSTRUCTION SITE. IT HAS ADS ADVERTISING THE PROJECT, HOWEVER, IT PROTECTS THE GENERAL PUBLIC FROM POTENTIAL DANGERS ON THE CONSTRUCTION SITE. SINCE THE SITE IS MORE THAN 2M AWAY FROM THE SIDEWALK, ONLY A PROTECTIVE WALL IS NECESSARY. (s. 2.7.1)

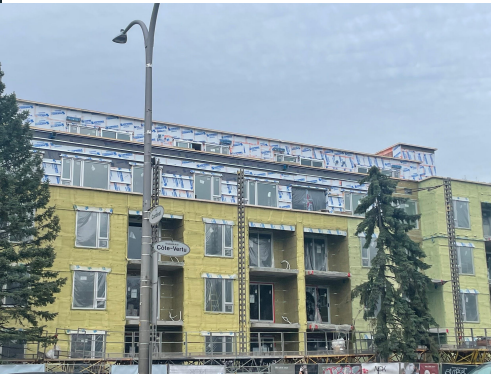
THE MAST-CLIMBING WORK PLATFORM DOES NOT HAVE PIERS THAT GO ALL THE WAY TO THE TOP OF THE BUILDING WHICH IS WHY THE TOP PART DOES NOT HAVE INSULATION FOAM YET. THEY WILL HAVE TO ADD GUARDRAILS ON THE ROOF AND ANCHOR POINTS TO ALLOW WORKERS TO WORK SAFELY ON THE ROOF AND THE HIGHEST FLOOR. THIS FALL ARREST SYSTEM WILL BE DESIGNED BY AN ENGINEER SINCE IT IS A TEMPORARY STRUCTURE AND IT WILL HAVE A CONFORMITY CERTIFICATE SIGNED BY THE ENGINEER WHEN IT IS BUILT CORRECTLY. (s. 3.9.22(1))

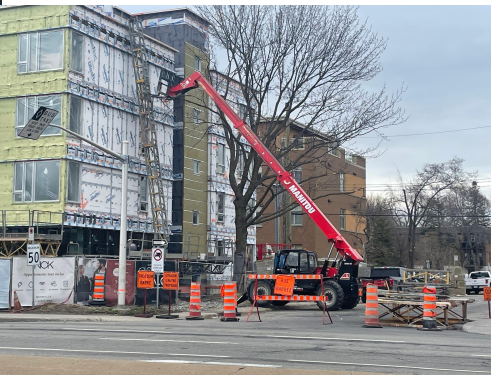
THERE IS A BOOM TRUCK WITH AN OPERATOR ASSEMBLING THE MAST-CLIMBING WORK PLATFORM ONTO THE RIGHT SIDE OF THE BUILDING. THERE ARE ORANGE CONES AND A SIGN ON THE STREET THAT RESTRICT ACCESS TO THE STREET FROM THE PUBLIC FOR THEIR SAFETY. THERE IS ALSO A BARRIER BLOCKING ACCESS FROM THE BEHIND THE CONSTRUCTION SITE TO RESTRICT STREET ACCESS FROM BOTH SIDES. ROADWAY SIGNAL SIGNS ARE INCLUDED IN THE CIRCULATION PLAN DESIGNED BY THE GENERAL CONTRACTOR. (s.10.3.1.)

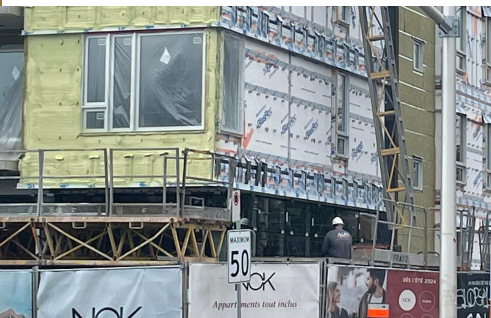
THERE IS A WORKER ON THE MAST-CLIMBING WORK PLATFORM. HE IS PROBABLY ASSEMBLING THE PLATFORM AS WELL. HE IS WEARING HIS PERSONAL PROTECTIVE EQUIPMENT, BUT ONLY THE HARD HAT IS VISIBLE IN THIS PICTURE. THE WORKER IS WEARING A WHITE HARD HAT, SO IT COULD BE A CONTRACTOR SPECIALIZED IN ASSEMBLING TEMPORARY STRUCTURES. ONCE IT IS BUILT, THE ENGINEER THAT DESIGNED THE MAST-CLIMBING WORK PLATFORM FOR THIS CONSTRUCTION SITE MUST EVALUATE THE PLATFORM AND SIGN A CONFORMITY CERTIFICATE THAT IS AVAILABLE ON THE SITE AT ALL TIMES. (s. 3.9.22 (1))

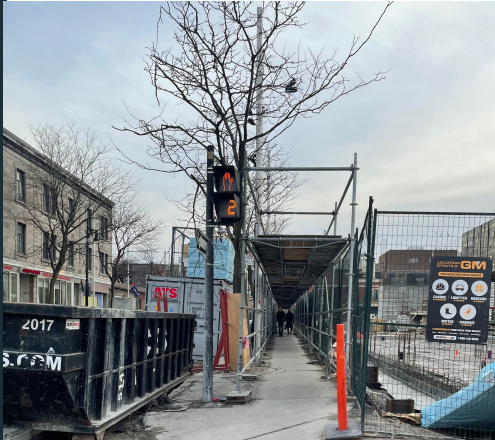
THERE IS A SIDEWALK PASSAGE SINCE THE CONSTRUCTION SITE IS LESS THAN 2M AWAY FROM THE SIDEWALK AND THE ACTIVITIES ON THE CONSTRUCTION SITE WOULD CAUSE DANGER TO PEDESTRIANS. (s. 2.7.1) THERE IS ALSO A SAFETY SIGN ON THE FENCE WHICH INDICATES THAT WEARING A HARD HAT, SAFETY GLASSES, A REFLECTIVE VEST, CONSTRUCTION BOOTS AND A HARNESS ARE MANDATORY AT ALL TIMES ON THIS CONSTRUCTION SITE. (s. 2.10.)

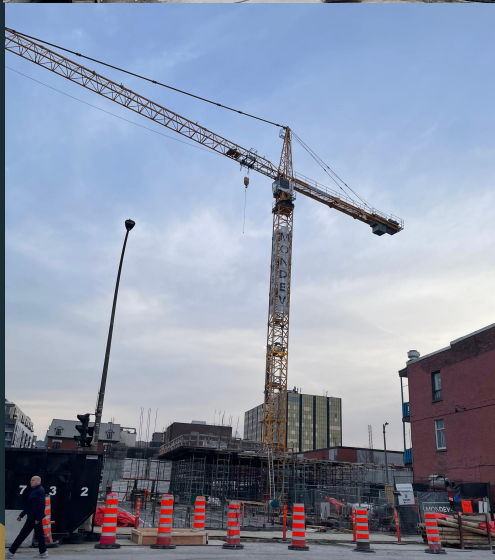
THERE IS A TOWER CRANE ON SITE, IT IS NOT IN OPERATION, HOWEVER, IT IS ALREADY ASSEMBLED AND WE CAN NOTICE THE COUNTERWEIGHT AT THE EDGE. THE CRANE IS NOT AS TALL AS THE TOWER CRANE FROM THE NORIA APARTMENTS VISIT SINCE THERE IS NOT MUCH HEIGHT TO THE BUILDING YET. THE CRANE MUST CONFORM TO THE CSA STANDARDS FOR TOWER CRANES. ITS LOG BOOK MUST BE KEPT UP TO DATE IN ACCORDANCE TO THE STANDARDS. (s. 2.15.7.4.)

NEXT TO THE CRANE, THERE IS AN ELEVATED PLATFORM WITH GUARDRAILS, SINCE THIS IS A TEMPORARY STRUCTURE, IT HAS BEEN DESIGNED BY AN ENGINEER, SIGNED AND SEALED AND THE COMPLIANCE CERTIFICATE WAS ISSUED AND IT IS KEPT ON THE SITE. (s. 3.3.1.)

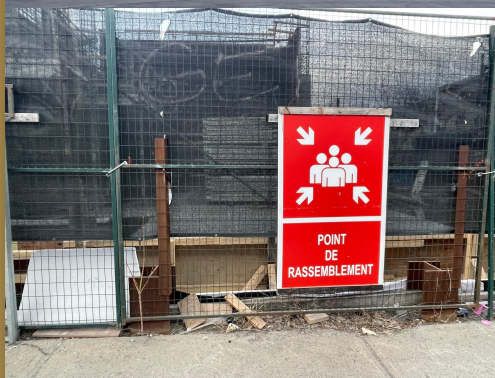
THERE IS A PLACARD THAT INDICATES THE ASSEMBLY POINT OF THE CONSTRUCTION SITE, IN THE CASE OF EMERGENCIES. IF THERE WERE TO BE A CASE CONTAINING EXPLOSIVES ON THE SITE CONSTRUCTION, IT WOULD BE LOCATED AT LEAST 15M AWAY FROM THIS MEETING POINT. (s. 4.4.1.1.)

ON THIS SIDE OF THE SIDEWALK THERE IS ONLY A FENCE BECAUSE THERE ARE NO OVERHEAD THREATS TO PEDESTRIANS.

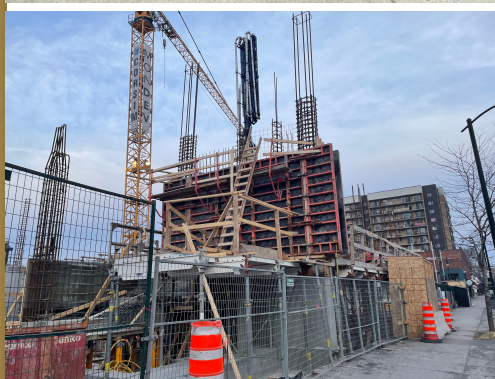
THERE IS A PLATFORM WITH A GUARDRAIL AND A LADDER LEADING TO THE TOP OF ANOTHER PLATFORM WHERE COLUMN REBARS ARE STICKING OUT. SINCE THERE ARE NO STAIRWAYS OR RAMPS LEADING TO THE PLATFORM, A LADDER IS USED. THIS LADDER WAS BUILT ON SITE AND ACCORDING TO THE CONSTRUCTION SAFETY CODE, IT MUST HAVE A MAXIMUM LENGTH OF 4.8M, THE WIDTH MUST BE A MAXIMUM OF 400MM AND STEPS MUST BE LESS THAN 300MM APART FROM EACH OTHER. THE LADDER ON THE PICTURE IS MADE OUT OF WOOD, SO IT MUST HAVE GOOD CONDITION 38MM x 89MM WOOD. (s. 3.5.4.)
