BUILDING INSPECTION REPORT

Address: 28 54e Avenue Ouest, Blainville, Quebec, J7C 1M9

Vanier College Architectural Technology

House Pre-Purchase Inspection Assignment

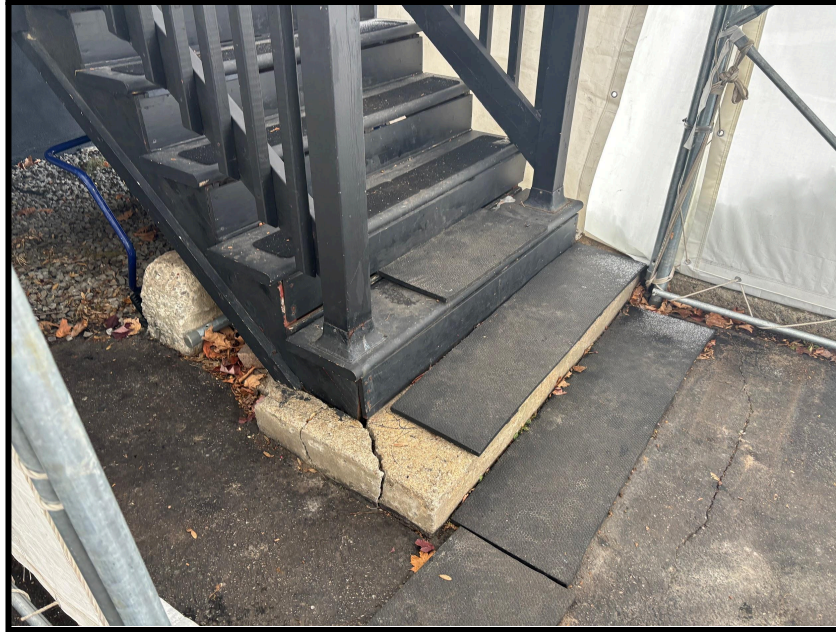
The main deck at the front entrance is constructed of wood and is accessed via a staircase with a 7 ½" rise and 10" tread, which appears to meet typical stair dimensions for safety and usability. The supporting concrete slab under the staircase exhibits a large diagonal crack, which may indicate minor settling or stress; while no immediate structural failure was observed, it is recommended that a qualified contractor or structural engineer assess the slab to determine if repairs are needed. The wooden deck itself is in fair condition, showing visible signs of aging, weathering, and some rusted fasteners at the base. Routine maintenance, including tightening or replacing rusted screws and applying protective wood treatment, is advised to prolong the deck's lifespan and ensure safety.

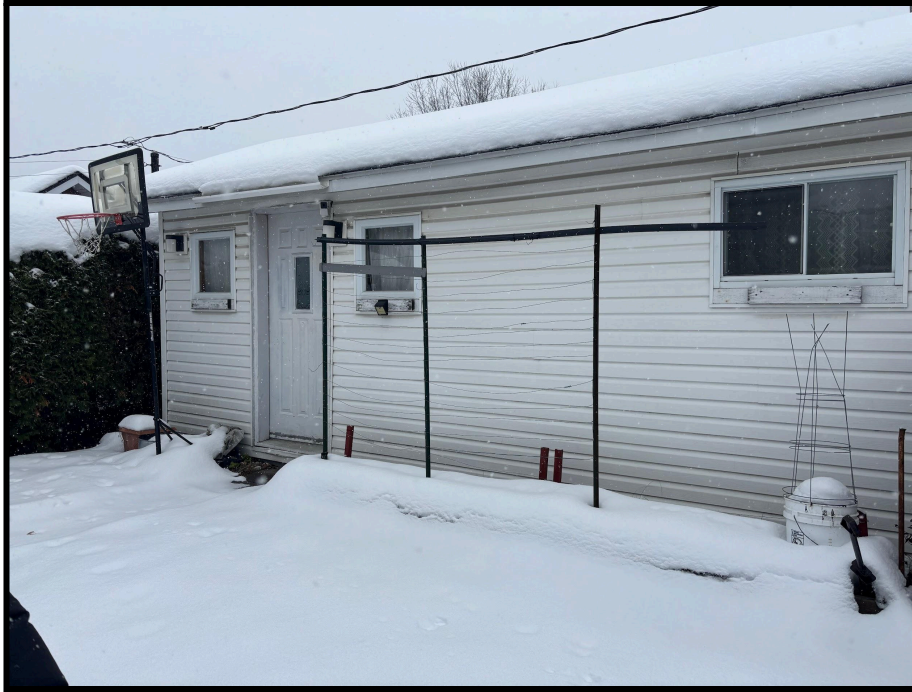
On the storage shed, the vinyl siding appeared intact overall with no major detachment or bulging visible. The lower parts and the back were not visible due to snow accumulation or accessible due to the fence, the full condition was not verifiable. The exterior door and window appear to be old but are fully operational. The trim shows signs of aging and weathering. There is no obvious flashing present above the window or door which can be a risk for water infiltration. The roof structure is fully hidden by the snow. The storage shed has a gutter right above the door, and there was no soffit venting visible.

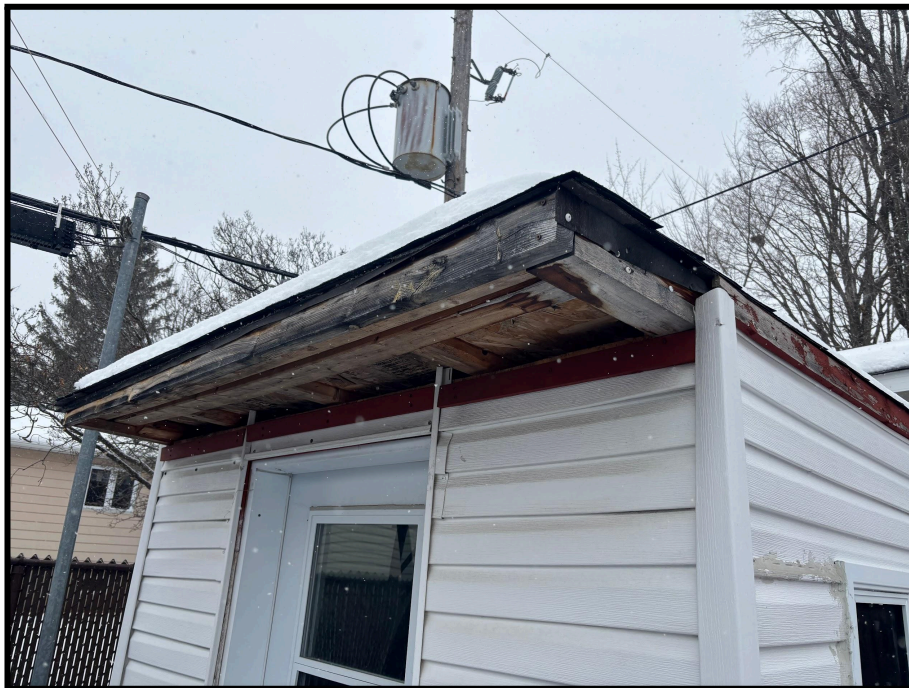
Pool shed

The pool shed has intact vinyl siding but the trim at the top corners shows paint peeling. There is a missing drip edge or fascia. The door is functional and in good condition. The roof has exposed wood sheathing under the eaves and dark staining and cracking potentially due to moisture exposure.

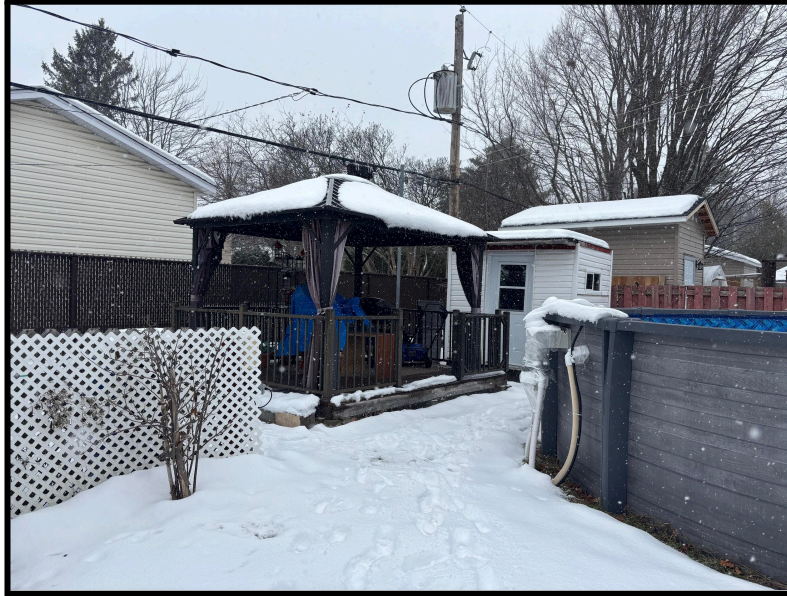
Other auxiliary structures on the property include an Ipe wood gazebo with aluminum railings. The gazebo appears to be in good condition, with no visible signs of structural damage, decay, or significant wear. The Ipe wood shows normal weathering consistent with outdoor exposure, and the aluminum railings appear stable and free from corrosion. Routine maintenance, such as cleaning and sealing of the wood, is recommended to preserve its longevity and aesthetic appearance.

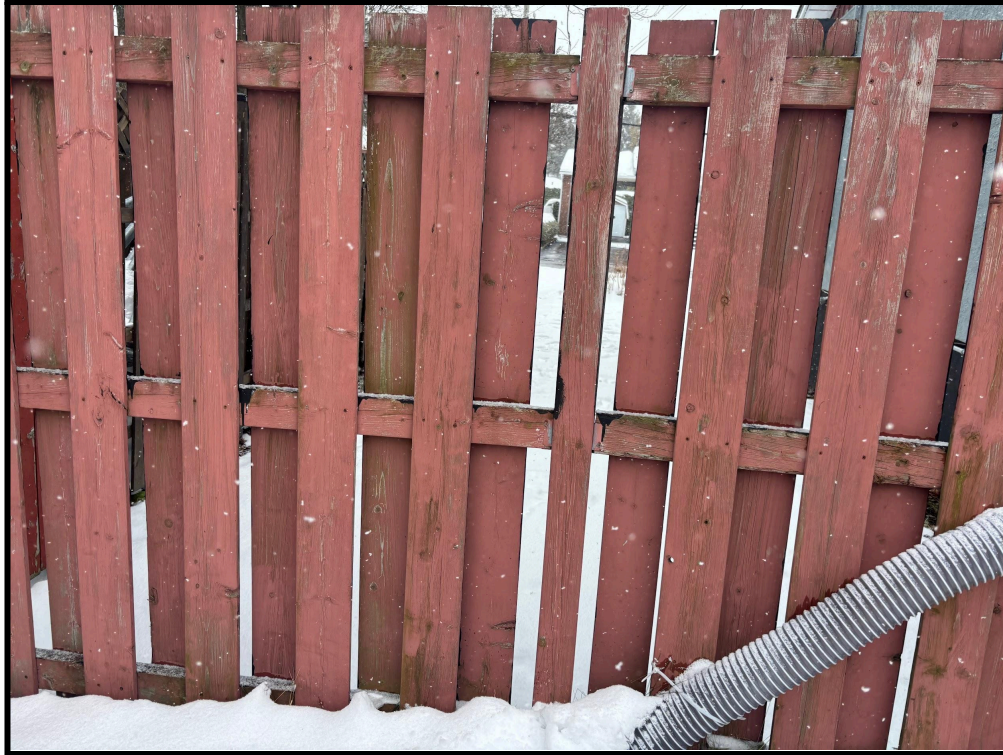
The property is enclosed by a combination of a wooden fence and a bush fence, providing perimeter security and delineation of the lot. The wooden fence shows areas of discoloration, which may indicate exposure to weathering, moisture, or potential surface degradation. While no structural instability was observed at the time of inspection, ongoing monitoring and maintenance are recommended to prevent further deterioration. The bush fence appears generally intact, though periodic trimming and upkeep are advised to maintain its effectiveness as a boundary and visual barrier.

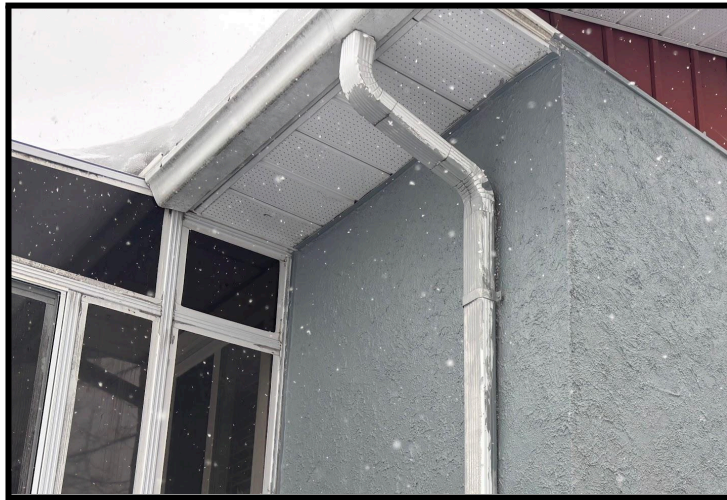
Aluminum gutters are installed along the roof edges and appear clean, properly secured, and set at an adequate slope to facilitate water drainage. Regular maintenance is recommended, including seasonal cleaning to prevent debris buildup and to ensure continued proper flow away from the building.

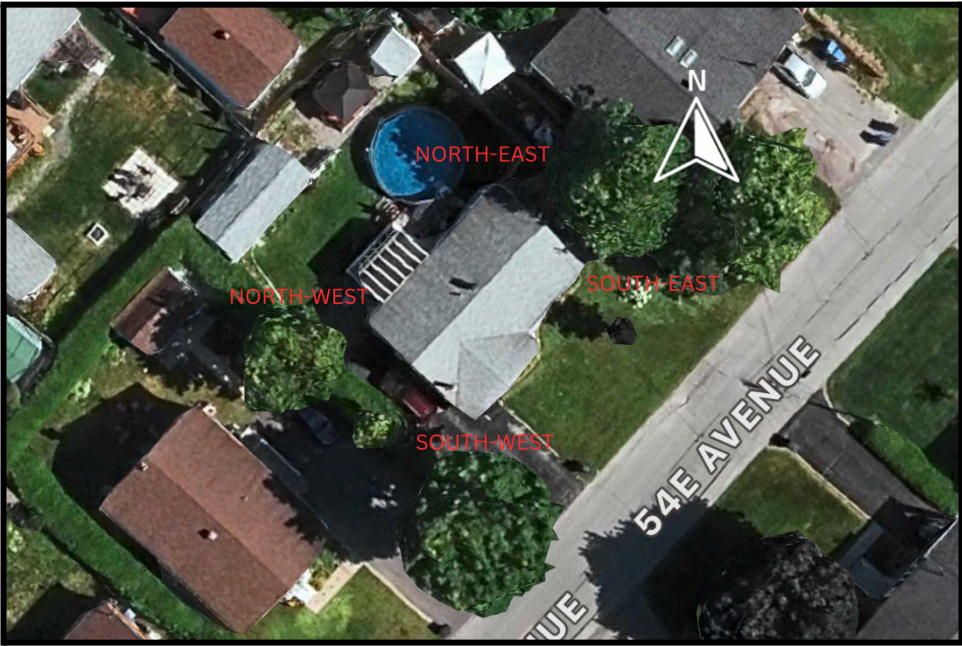
Downspout location on map

PVC downspouts are installed at each corner of the building. The south-west downspout extends 6'8" from the foundation, the north-west downspout extends 3', the south-east downspout extends 2'8", and the north-east downspout extends approximately 8'. The placement of downspouts meets the recommended guideline of installing one every 35 feet of gutter length. However, downspout extensions should discharge water a minimum of 4 feet from the building's foundation. It is recommended that the shorter downspout extensions be evaluated and adjusted by a qualified gutter or plumbing specialist to ensure proper drainage and reduce the risk of water infiltration. Regular maintenance of the downspouts is recommended, including annual cleaning and

ensuring that all extensions remain securely attached and positioned to discharge water at least 4 feet away from the foundation.

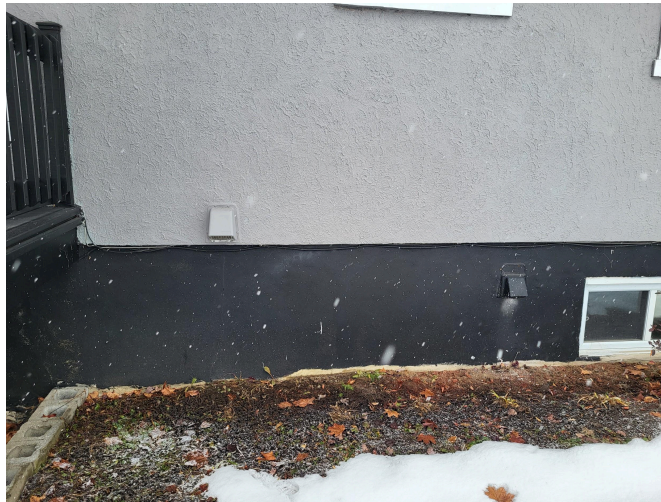
The exterior foundation wall is at an acceptable condition, with no visible cracks on the surface at the time of the inspection. The cement parging is also free from scratching, spalling and efflorescence and is in very good condition.

Cement parging located at the front side of the house.

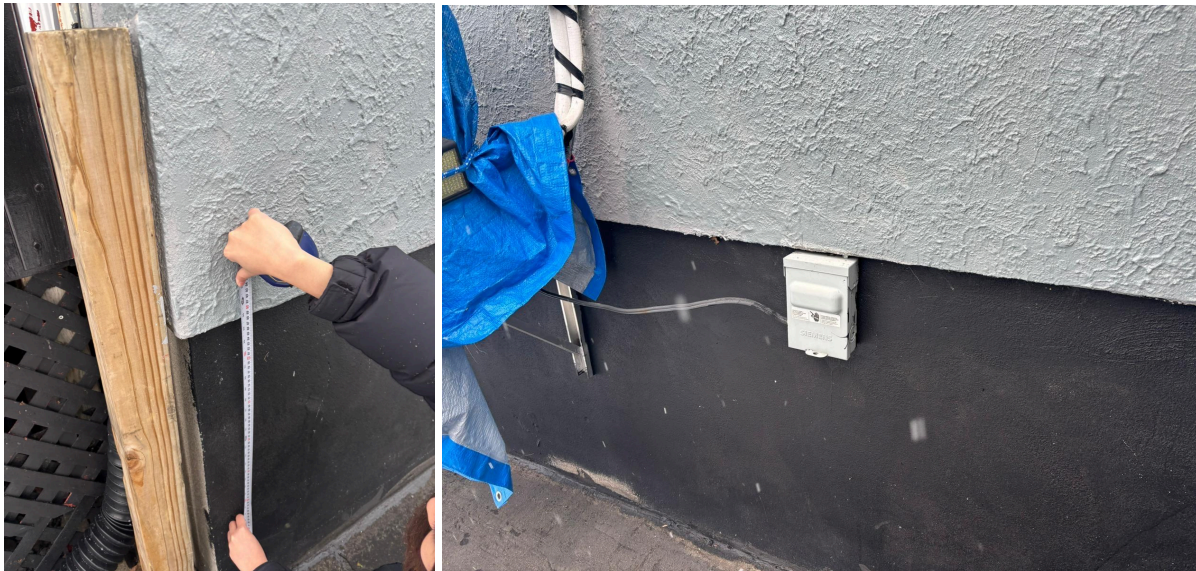
Cement parging located at the east side of the house.

The purpose of the cement parging is to protect the concrete wall from the weather and water absorption. Water is absorbed by the foundation wall's porous surface through capillarity. During the winter, this water freezes inside the wall, eroding the concrete's surface and perhaps causing fissures. It is recommended to do regular maintenance for the cement parging in case it needs a replacement coating.

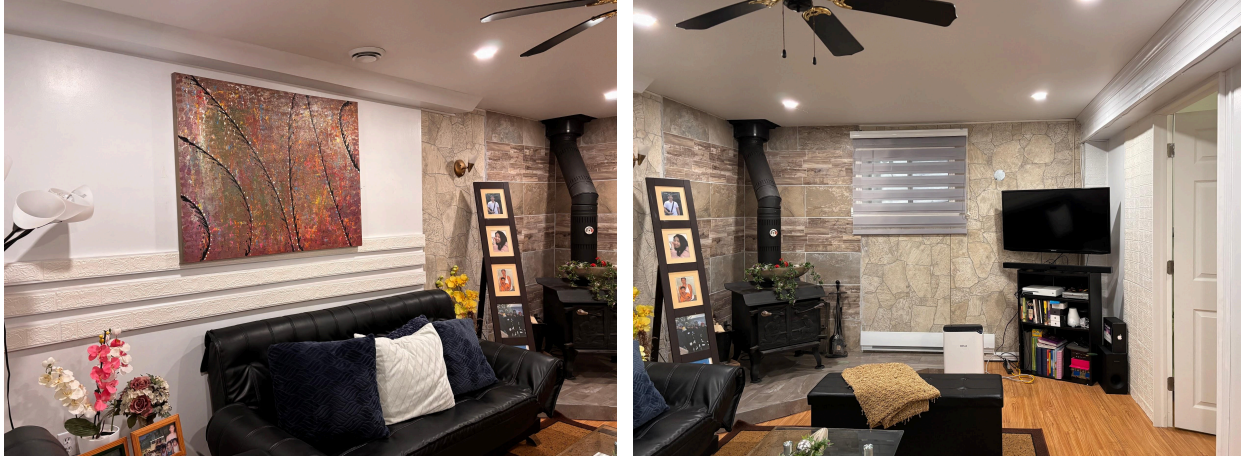
From inside the basement, it was impossible to assess the condition of the foundation walls since most of them are covered with drywall. Moreover, the walls around the basement windows were covered with drywall as well, so the cracks cannot be verified for water infiltration.

Fully finished interior wall and completely furnished room

At every crack that runs under the ground, the ground should be excavated to expose the foundation wall, the crack should be sealed with pressure-injected epoxy resin or structural polyurethane from the outside and inside all the way to the base of the brick, and a waterproof membrane should be applied to the exterior face of the wall. A foundation specialist should repair these cracks under the supervision of a structural engineer.

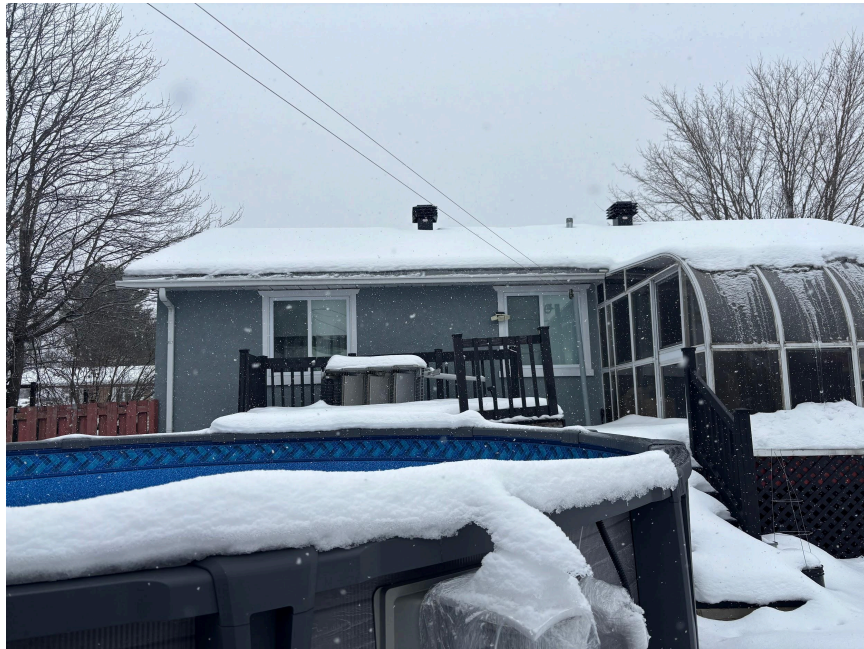
View of the roof at the south side of the house (backyard)

All roofs should be maintained and inspected twice a year for premature wear, also the joints of the metal flashings should be inspected yearly and sealed as required since these joints deteriorate quickly in extreme weather conditions and water infiltration may occur.

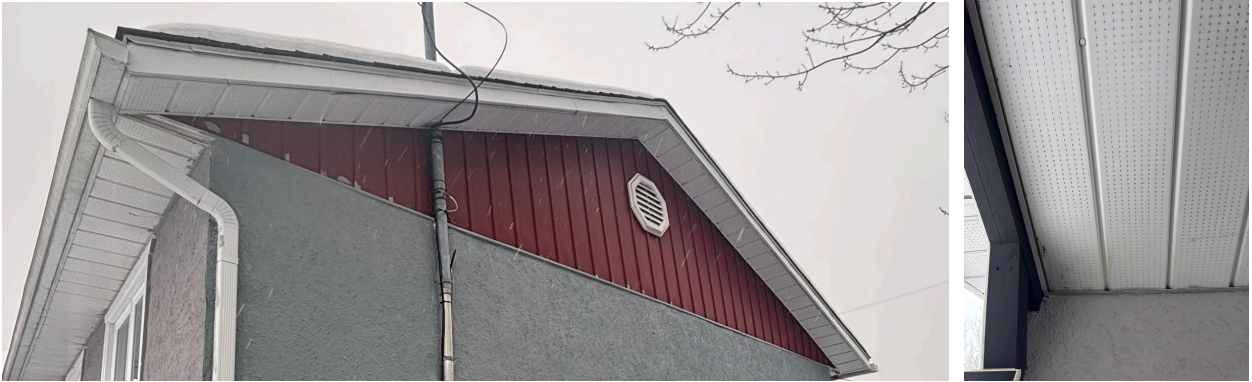
The perforated prepainted aluminum soffit panels appear to be relatively new construction and in very good condition. Moreover, no drop-out panels are observed during the visual inspection and all are secure in position.

The aluminum fascia also appears to be relatively new construction and in very good condition. No visible degradation, rust or cracks are noted during the visual inspection.

The aluminum soffits should be checked regularly, examining the joints of the panels to ensure that there are no open gaps to allow water infiltration inside the wall cavity. If any open joints or gaps are detected they should be closed immediately and sealed with watertight caulking or silicon to prevent serious damage to the wood structure of the wall due to water infiltration.

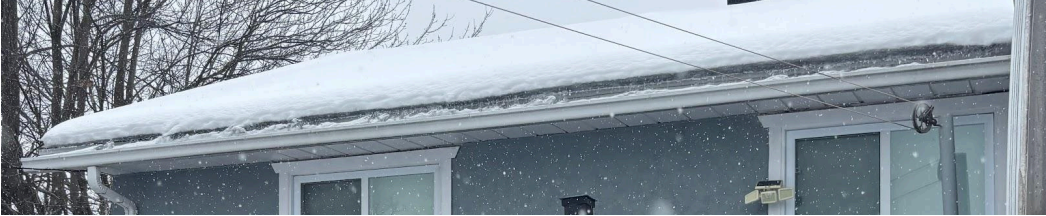
The eavestroughing (gutters) are made of prepainted aluminum, which is generally durable and corrosion-resistant. There were no visible signs of significant damage, sagging or detachment observed at the time of inspection.

Gutters and downspouts should direct water runoff away from the base of the foundation. It is recommended that the gutters should be cleaned twice yearly to ensure proper water drainage and prevent blockage, overflow and deterioration of the gutter system.

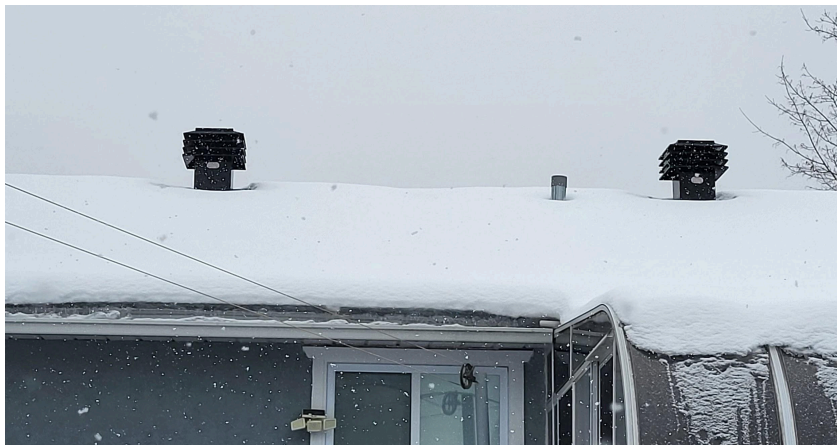
Only a visual inspection was done for the chimneys. A Class 1, two-flue chimney made of stainless steel pipe is located at the center of the roof. It is confirmed by the owner that the flue on the eastern side (for the furnace located at the family room) is no longer in use. Both flues have GC1 Flue Liner Terminal for the chimney cap.

It is recommended that the chimney should be swept once a year. It is also suggested to call the local fire department or a chimney expert to certify the condition of the chimneys and to verify that their condition is safe and does not represent a risk or a fire hazard. Some local fire departments provide this service free of charge (check the municipality for the cost).

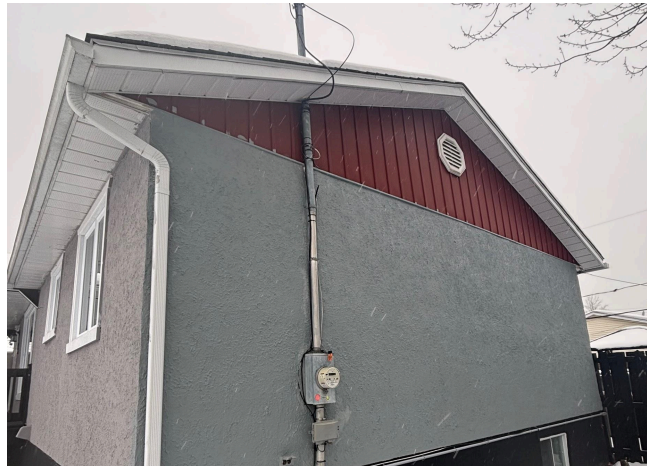
The stucco appears to be relatively new construction and in good condition, with no immediate signs of structural failure observed at the time of inspection. Some minor surface cracking and finish irregularities were noted; however, these conditions are common in stucco systems and may not be indicative of underlying structural concerns. Cracking of the surface finish may result from thermal expansion, movement of underlying materials, or insufficient reinforcement.

- The condition of the stucco can be periodically monitored and immediately repaired when damage is found, and all caulked seams and joints must be rigorously maintained.
- It is advised that a qualified building envelope professional evaluate the observed conditions to determine whether there are any necessary preventative measures.

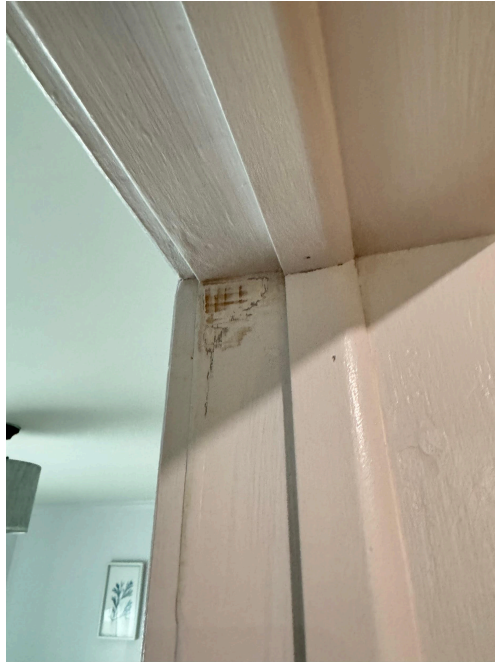
Interior doors within the home are made of built-up solid core wood construction. All are in good condition, and operate satisfactorily (except for the door to the master's bedroom, where the closing grazes the top right of the door frame).

Grazing from the door opening of the master's bedroom.

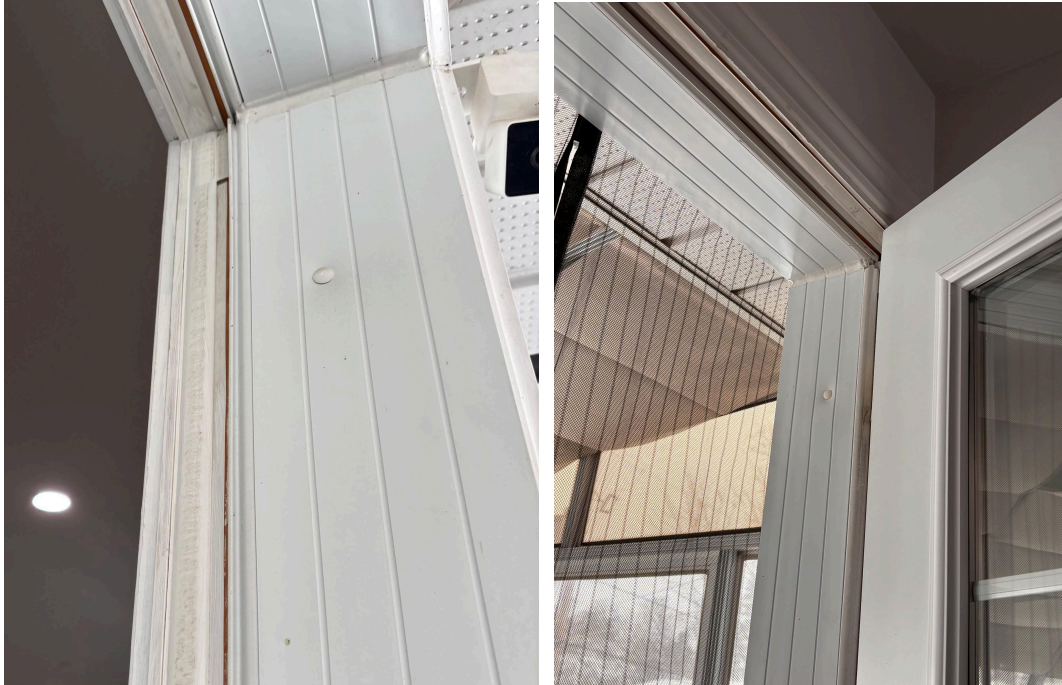
Caulking and sealant conditions at the main entrance and backdoor entrance, respectively.

- In order to maintain the door's longevity and durability, routine monitoring and maintenance of the caulking and door seals are recommended, as silicone sealants can degrade over time due to exposure to weather, temperature fluctuations and thermal movement.
- Where gaps are too large to fill with caulk, a compressible foam backing rod (such as "Rodofoam") should be fitted, over which caulking may be applied.

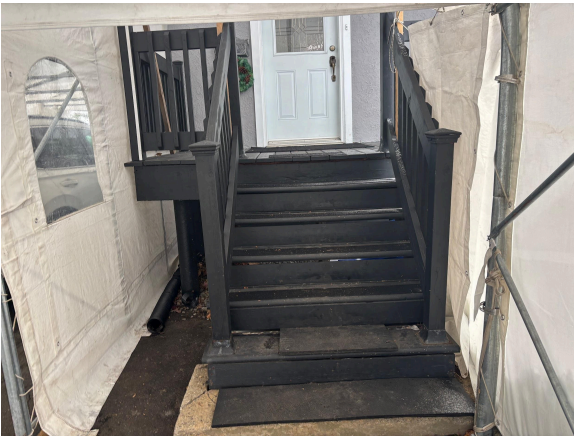
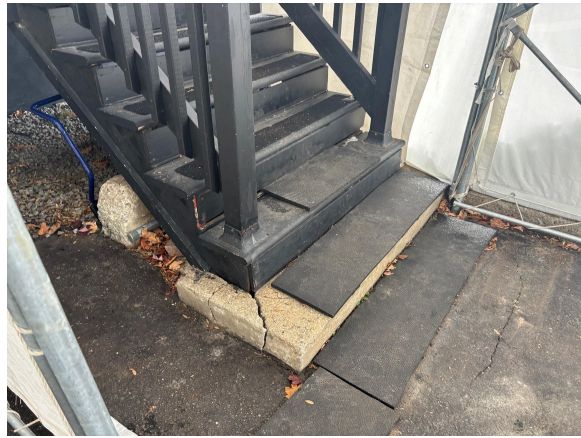
For the front balcony, no visible damages were observed to the surface materials, railings, or support components (except for the concrete base of the stairs, which has a huge crack at the left side). The overall structure appears stable, with no evidence of cracking, corrosion, warping, or other forms of deterioration typically associated with prolonged exposure to weather elements. All accessible areas were secure and free from safety hazards at the time of inspection. While no concerns were identified during this visual assessment, continued routine maintenance is recommended to ensure the balcony remains in sound and serviceable condition.

Stairs and balusters at the balcony of the main entrance.

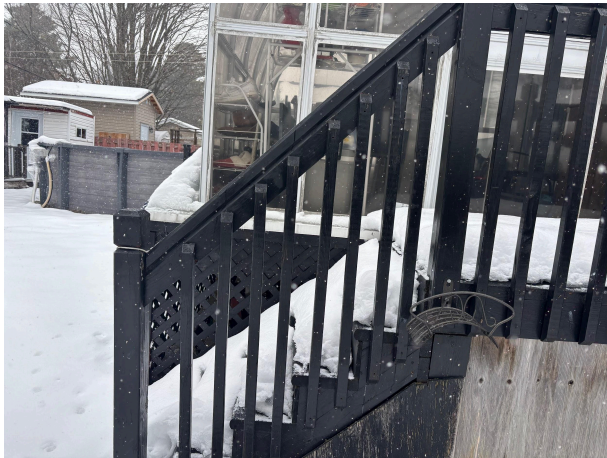
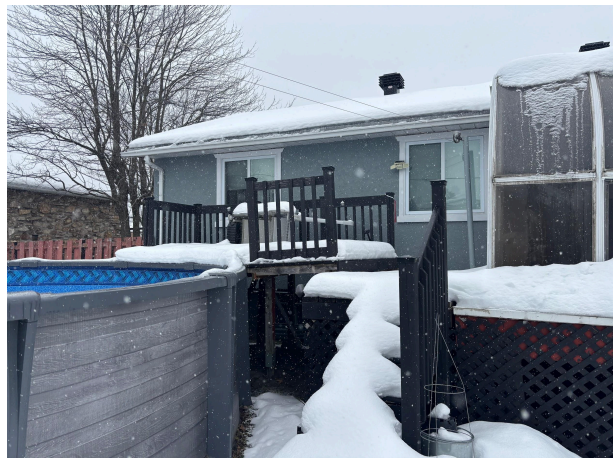
On the other hand, the stairs for the backyard porch/balcony also had no visible damages to the surface materials, railings, or support components noted during the time of the inspection. However, the overall structure appears to not be stable: the platform is tilted and higher than the usual height from the staircase landing.

Stairs and balusters at the balcony located at the backyard.

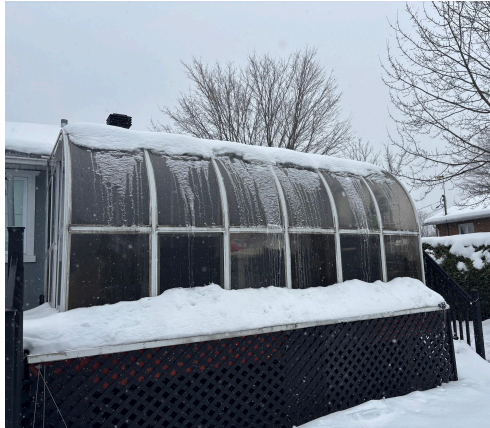
The solarium/sun room is made of clear acrylic plexiglass PVC construction. It has 2 doors at each side that goes directly to the backyard. The mullions are of aluminum metal, making it sturdier and durable. No condensation was observed during the inspection, but moisture infiltration is visible at the bottom of the solarium/sun room. The caulking is poorly adhered; therefore, the water from the accumulated snow (when melted) seeps through the joints.

Solarium / Sun room view located at the backyard of the house.

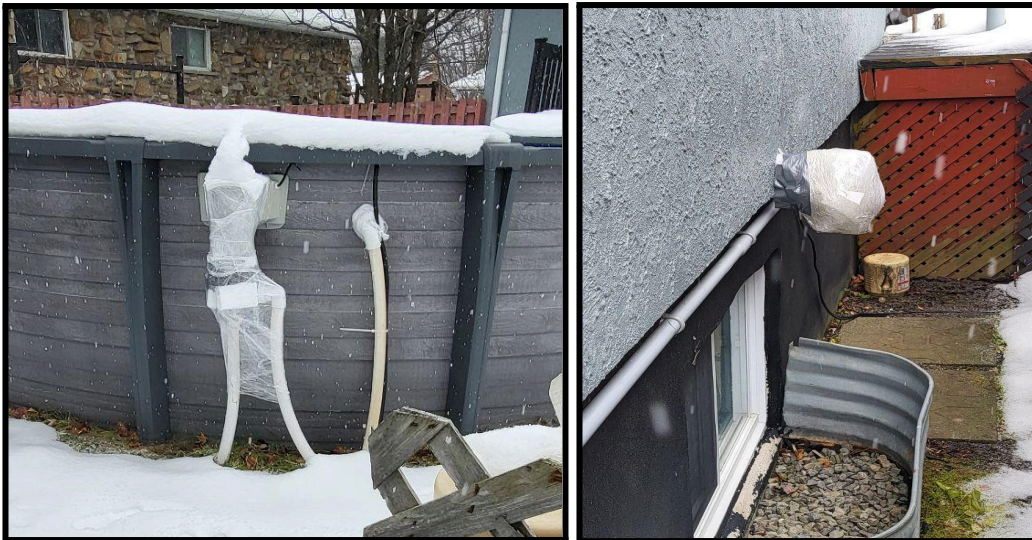
The Pool and the Exterior Faucet

The exterior faucet could not be inspected because it was fully covered by the homeowner for the season. The outdoor pool equipment and connections were also not inspected, as the pool was closed and not accessible at the time of the visit. These components were not visible, and their condition could not be confirmed.

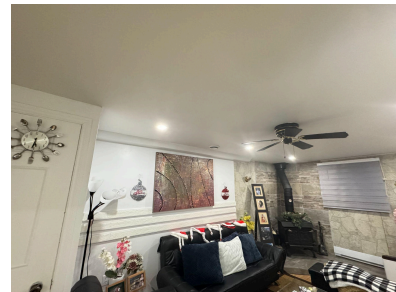
Comments: The family room was overall in good condition. The ceiling, wall, and floors finishes show no visible cracks, stain, or signs of water infiltration. Windows are functional. Electrical fixtures are greatly functional and show that it's recently changed.
