BUILDING INSPECTION REPORT

Address: 28 54e Avenue Ouest, Blainville, Quebec, J7C 1M9

Vanier College Architectural Technology

House Pre-Purchase Inspection Assignment

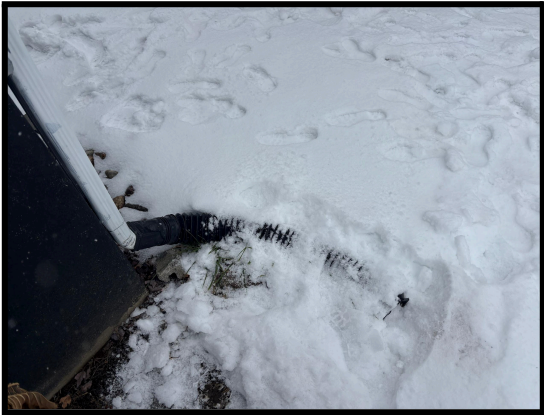
South-East

PVC downspouts are installed at each corner of the building. The south-west downspout extends 6'8" from the foundation, the north-west downspout extends 3', the south-east downspout extends 2'8", and the north-east downspout extends approximately 8'. The placement of downspouts meets the recommended guideline of installing one every 35 feet of gutter length. However, downspout extensions should discharge water a minimum of 4 feet from the building's foundation. It is recommended that the shorter downspout extensions be evaluated and adjusted by a qualified gutter or plumbing specialist to ensure proper drainage and reduce the risk of water infiltration. Regular maintenance of the downspouts is recommended, including annual cleaning and

ensuring that all extensions remain securely attached and positioned to discharge water at least 4 feet away from the foundation.

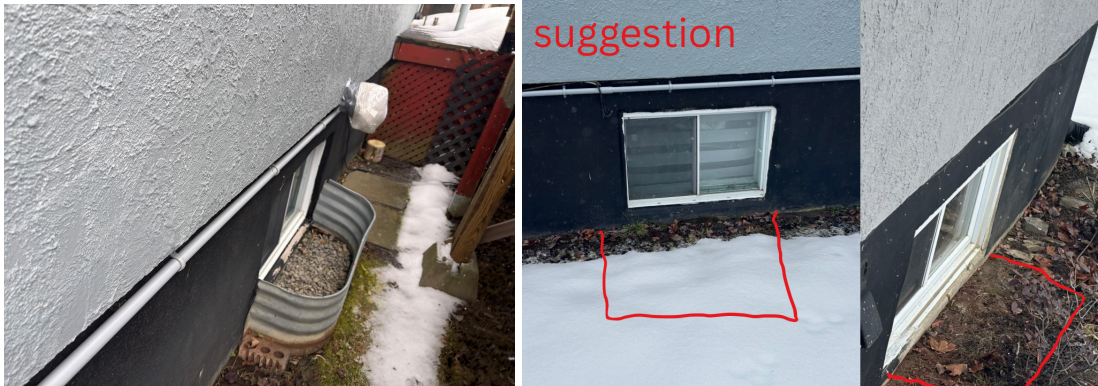
There is one window well present on the property. Window wells should ideally be installed at all basement or grade-level windows to prevent water infiltration and ensure proper drainage. It is recommended that the owner consider consulting a qualified professional to evaluate the windows that currently lack window wells and determine whether additional installations are required.

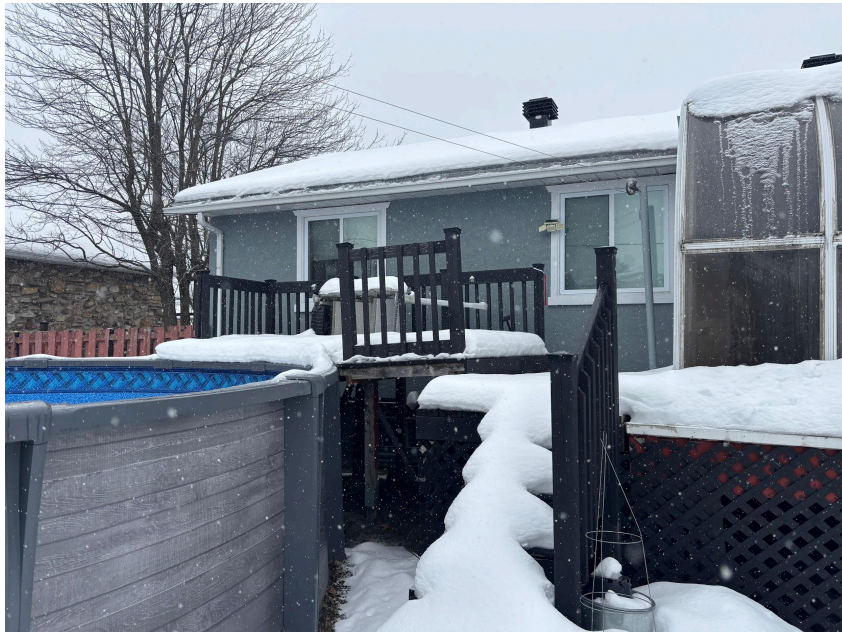
The backyard contains a 16-foot above-ground pool, which appears structurally stable; however, it lacks a safety fence, which is a compliance and safety concern. Installation of a proper enclosure is recommended to meet Québec pool safety requirements.

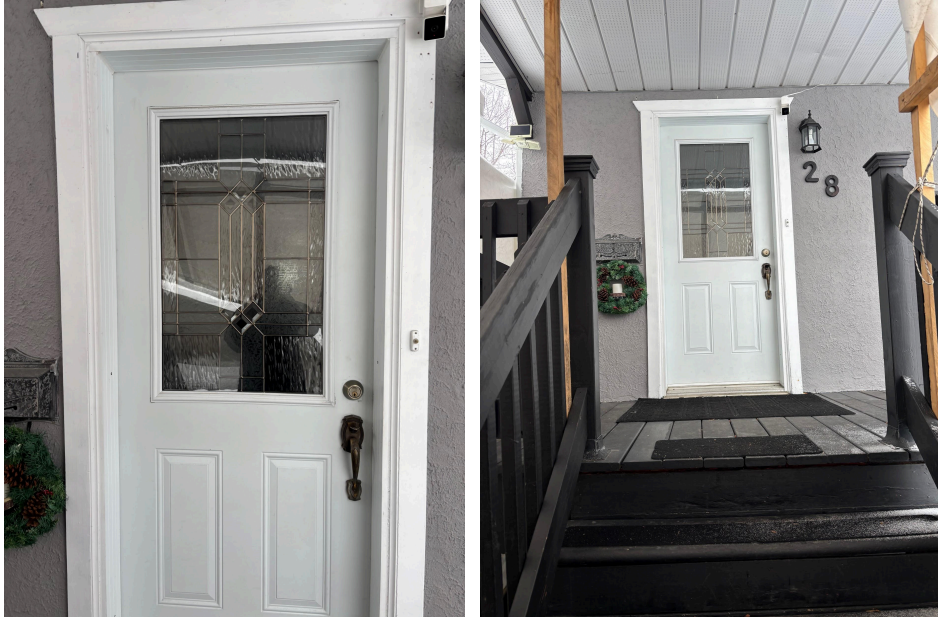
The front entrance door is of textured-glaze hollow core fiberglass insulated wood construction. The manufacturer's name is Masonite, and has a STC rating of approximately R-20. The door is in good condition, and operates satisfactorily.

Main front door entrance

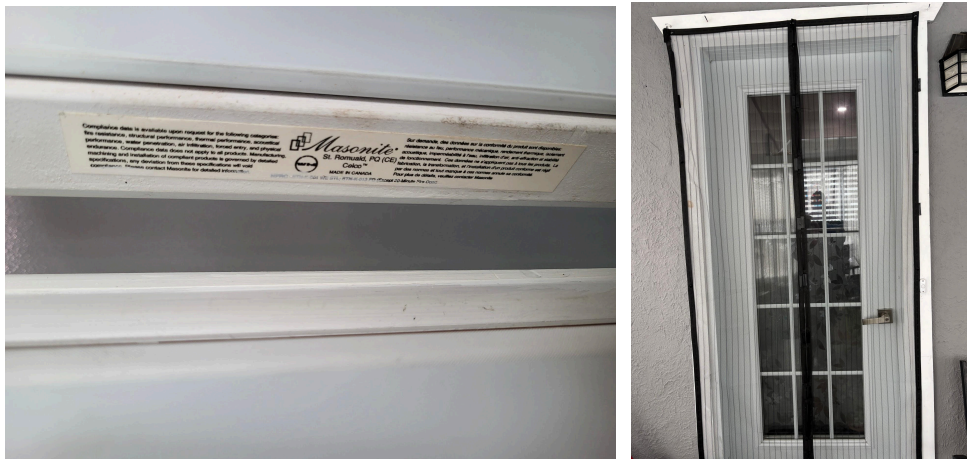
The backyard door (going to the solarium) is also of textured-glaze hollow core fiberglass insulated wood construction. The door is in good condition, and it too operates satisfactorily.

Back door entrance (with the specification and manufacturer sticker tag)

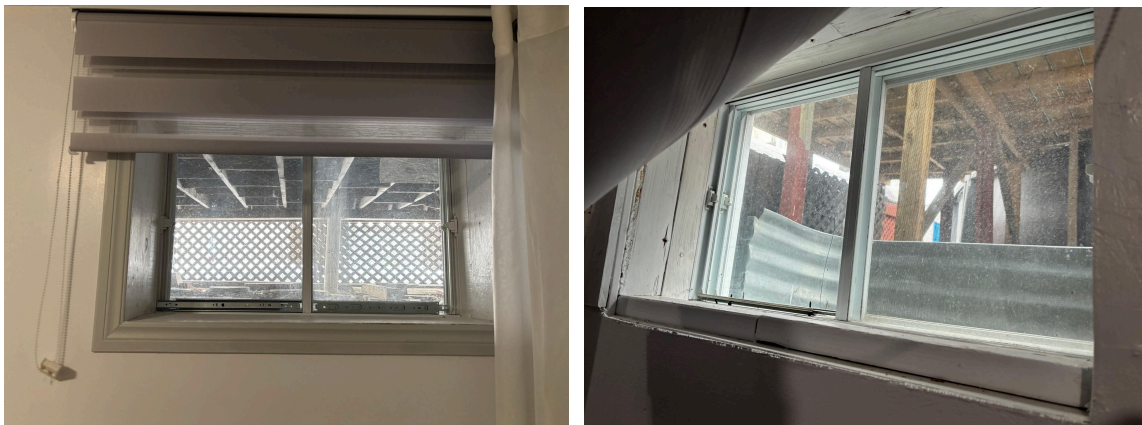
Windows at the basement level of the house are units of flush-glazed double pane horizontal sliding-sash PVC construction. They are with screens that are in good shape. All are in functional condition and operate satisfactorily (except for the window at the family room, in which the latch is forcefully sealed tight/locked, therefore impossible to open).

Windows at the basement bedroom #2 and mechanical room, respectively.

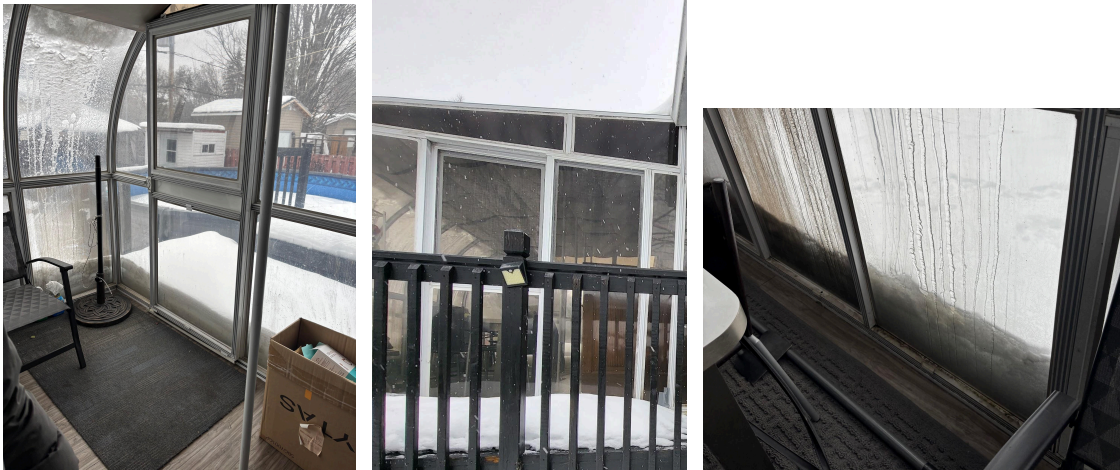
Side entrances for the solarium / sun room (1st and 2nd pictures), and joints at the bottom/flooring of the solarium / sun room (3rd picture)

Although plexiglass provides good clarity and thermal performance, it is generally more susceptible to surface scratching and yellowing discoloration due to ultraviolet radiation exposure over time. This makes the material become brittle and less transparent.

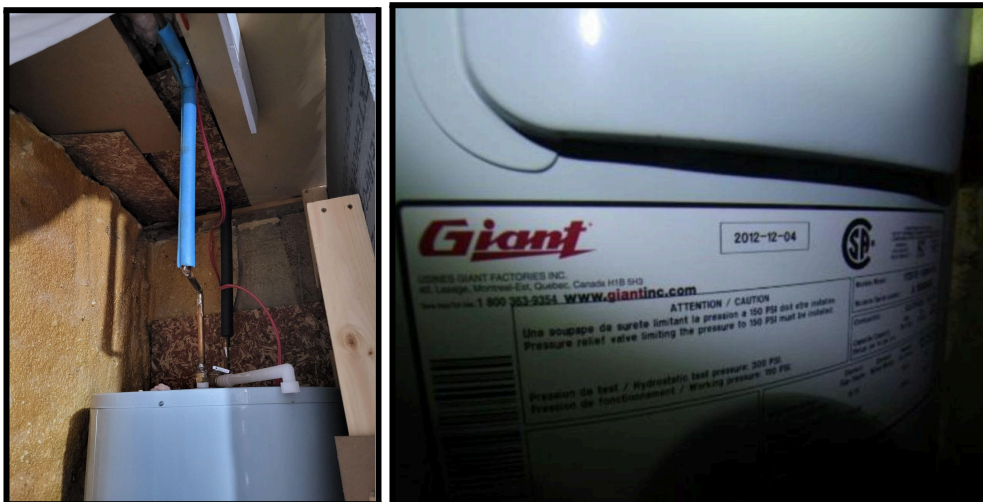
Hot Water Tank

The hot water tank is an electric Giant brand unit, manufactured on 2012-12-04. It has a capacity of 275 liters (60 gallons) and the life span is 15 years. Giant is a commonly used brand in residential buildings and is generally known for reliable performance. The tank appeared clean, with no visible rust, leaks, or missing components. The electrical wiring connected to the unit appeared to comply visually with typical installation practices.

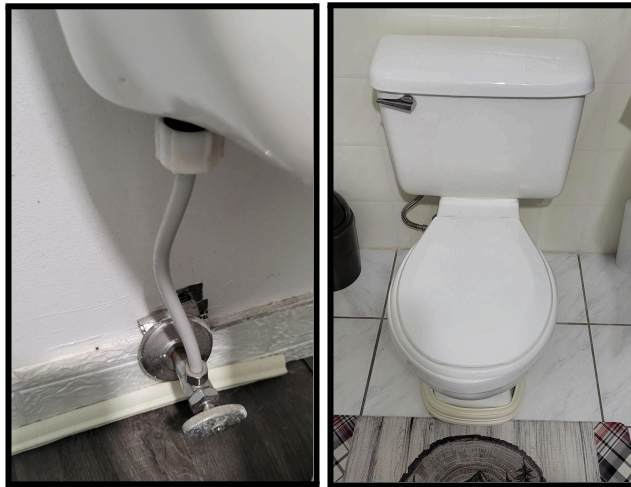
Toilet and the Shut Off Valve

The plumbing fixtures, including the toilets, sinks, and shower, appeared newer and in good condition. No leaks were observed around the fixtures, and shut-off valves were present where visible. Caulking appeared properly applied, and water pressure was consistent at all tested fixtures.

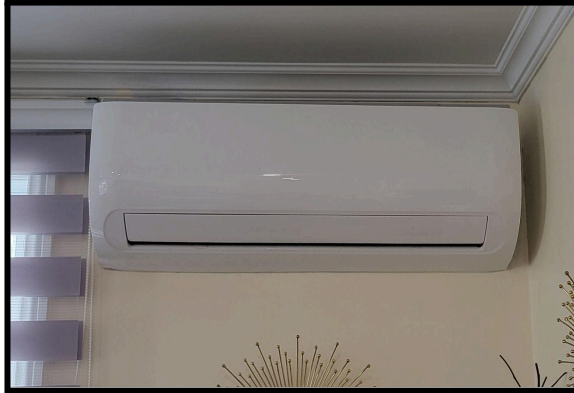
AC

A wall-mounted air conditioning unit is installed on the ground floor. The homeowner confirmed that the air conditioning is functioning properly. This was a visual inspection only, and no internal components were evaluated.

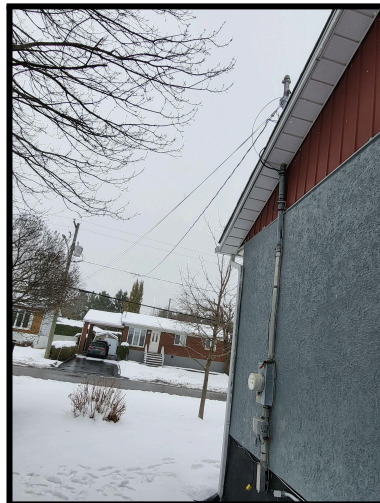
The Overhead Service

The type of electrical service is overhead. The system is rated at 200 amps with a 120/240-volt supply. The electrical meter is located on the East side of the house. It was accessible during the inspection, and no visible issues were noted with the meter or its enclosure.

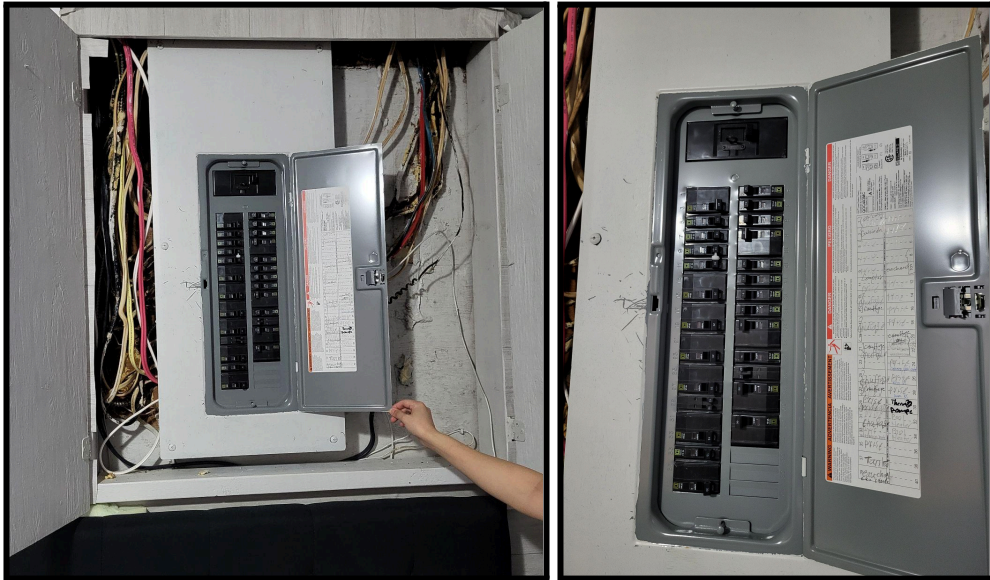
Main Panel

The main panel uses breakers. The panel cover and labeling appeared in acceptable condition, with no visible rust or damage. The wiring entering the panel had proper sheathing, although the interior wiring layout looked somewhat disorganized despite being labeled.

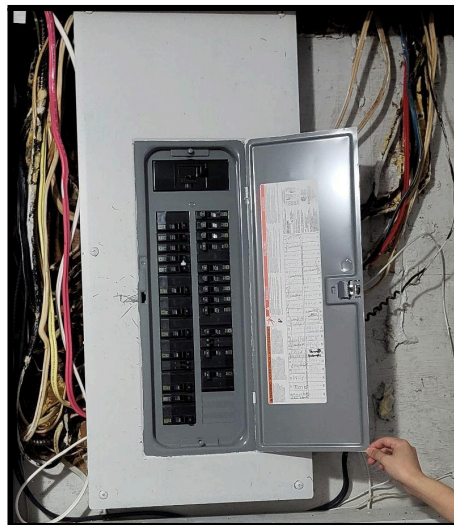
The Branch Wiring

Only about 5% of the branch wiring was visible, mostly inside the panel. The wiring is copper. Some of the visible wiring looked worn and should be checked or repaired by a licensed electrician.

A few issues were identified that should be addressed, such as ungrounded kitchen outlets, worn visible wiring in the electrical panel, minor floor gaps, and moisture concerns in the solarium/sunroom. Routine maintenance is recommended for the stucco, caulking, gutters, balconies, and mechanical systems to ensure long-term performance. The items that were not accessible during the inspection, in some parts of the foundation walls, the roof surface, and the pool equipment, should be monitored or reviewed when conditions allow.

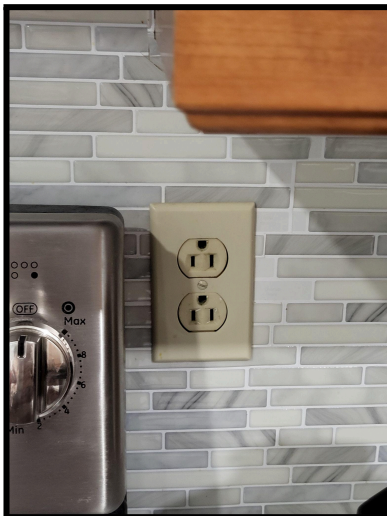
Kitchen outlet

I checked a sample of outlets and lights in the home. All the outlets in the bathrooms and the exterior outlets were grounded, except for the ones in the kitchen, where grounding outlets were missing. It would be recommended to update those outlets. The lights worked normally, and most areas had LED lighting, except for a few rooms that still used fluorescent lights. The exterior outlets were protected with ground fault circuit interrupters (GFCI) and showed no visible issues during the inspection.

It is recommended to replace the kitchen outlets with properly grounded outlets

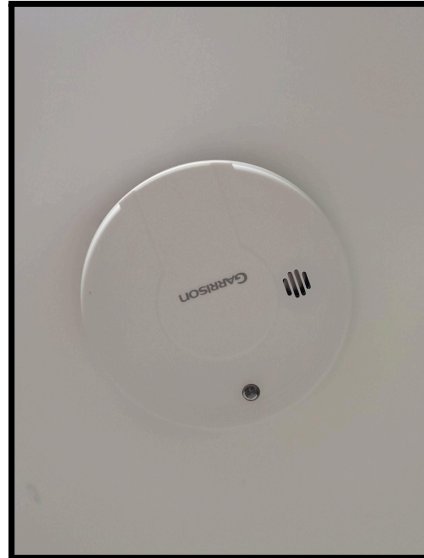
Smoke Detector

Two smoke detectors were present, one in the basement and one on the ground floor. Both appeared to be installed in appropriate locations.

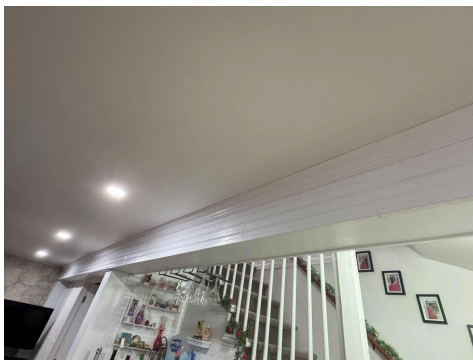
BEAMS: NOT VISIBLE

The beams, joists, and columns were fully encased with gypsum board at the time of inspection, limiting visibility and preventing a more detailed assessment of their condition. As a result, no further evaluation could be performed beyond what was accessible.

- Consider removing a limited portion of the gypsum board (**must be performed by a qualified professional**) for a proper evaluation of the beams.
- Consult a licensed structural engineer for further and detailed inspection to make sure that the structural integrity of the beams is good.
- Ensure that any future renovations or repairs provide temporary access to concealed structural elements for a proper inspection.

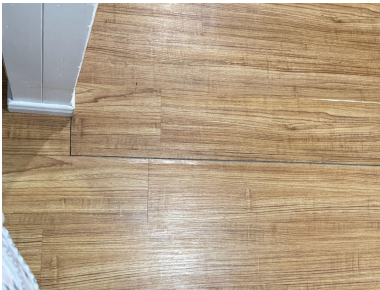
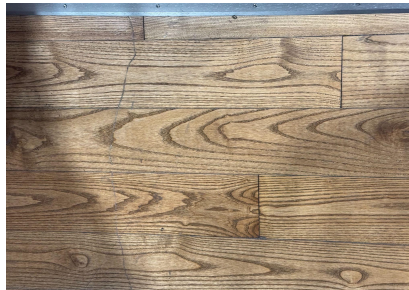
No major defects were noted. However, minor deficiencies were observed on the vinyl flooring, including parts of the floating floor and/ or hardwood floor showing gaps between boards. These conditions may be related to improper installation of the floor coverings.

- It is advised that a certified professional be engaged to examine the noted gaps between the floating floor and/ or hardwood floor and identify the underlying cause of the separation.
- Any affected sections should be corrected, reinstalled, or replaced to restore the proper alignment of the floor and mitigate further separation.

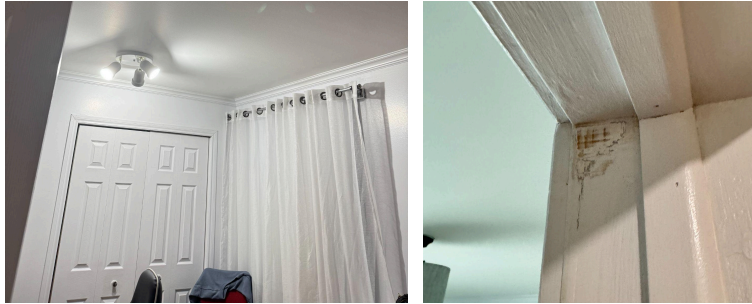
The master bedroom was visually inspected at the time of the visit. The hardwood flooring is in general condition with no significant damage present; some areas show minor wear due to frequent use. The gypsum wallboard and ceiling is also in good condition and no visible cracks, stain, or signs of moisture infiltration were observed. Closet doors, windows, and doors are functional as intended; however the door appears to be not properly closing as a normal door should be. Doors not closing properly may happen due to change of temperature or humidity makes the door expand or contract, as a result doors are harder to close.

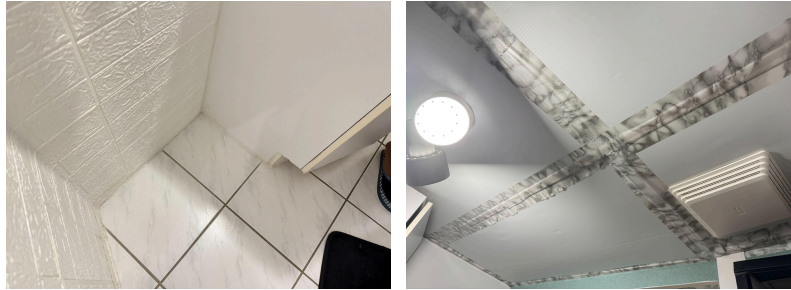
The bathroom basement was visually inspected at the time of inspection. The walls, floors, and ceilings are in fair condition. There are some visible cracks found in the ceramic floors. This may be a sign of the floor not properly leveled. The exhaust fan is fairly good though old, it's recommended to change it for better performance. Consideration of hiring a professional to inspect the condition of the walls for it may have problems where it cannot be determined by visual inspection.
